# Analysis Of Limestone Quarry Slope Stability, Nimbokrang District, Jayapura Regency, Papua, Indonesia

<sup>1,2,3</sup>Mining Engineering Department, Cenderawasih University, Papua

**Abstract**-Slope stability analysis generally uses the concept of factor of safety (FoS) value using several whole rock parameters. The slope stability analysis method that will be used in this research is the slope stability analysis method in open pit mines based on rock mass classification with the Rock Mass Rating (RMR) system and the Geological Strength Index (GSI) system and analyses the potential for landslides that can occur on slopes at that location with kinematics and limit equilibrium methods so that the type of landslide can be determined based on the intensity of the geological structure on the slope of the CV. Inti Jaya open pit limestone mine, in Wahab Village, Nimbokrang District, Jayapura Regency. This research aims to provide information on the current condition of the slope whether it is by safety standards, make slope engineering improvements and redesign safe slopes if unstable slope conditions are found. Research on the stability of limestone slopes begins with the collection

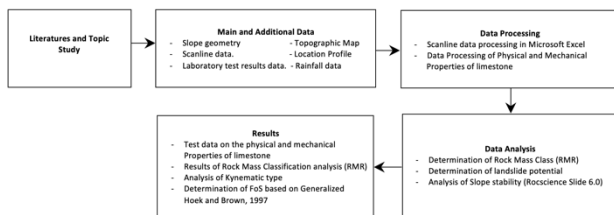
Figure 2. Research Flow Diagram

Primary data in this research are actual slope geometry data in the field, data from measurements of discontinuity areas in the field (scanline), and data from testing physical properties and mechanical properties in the laboratory. Meanwhile, secondary data is data used to support primary

Scanline measurement materials and equipment include a scanline data table, slope geometry table, geological compass, geological hammer, pocket meter, plastic rope, concrete nails, data board, 30 cm ruler, and writing tools. The software used to process scanline data is Microsoft Excel 2010 and Dips V7. Then for laboratory testing materials and equipment in the form of limestone samples from the research location, water, O'hauss balance, vernier calliper, desiccator, oven and PLI compressive strength equipment. The software used to process laboratory test data is Microsoft Excel 2010 and RocLab 1.0. This research's quantitative data collection technique results from measuring discontinuity areas on the mine slope (scanline). Several pictures of the research location are also needed as supplementary material for research data

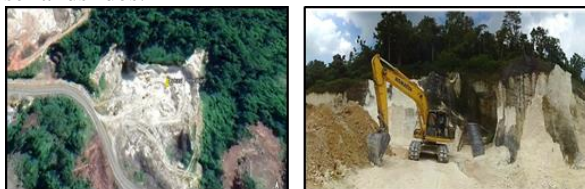
Figure 3. Top view and general location of the research

CV. Inti Jaya is administratively located in Wahab Village, Nimbokrang District, Jayapura Regency, Papua Province. Excavated materials from this location are used as fill material for constructing facilities in the Nimbokrang District. Astronomically, the research location is at coordinates 02° 32' 43.26" South Latitude and 140° 11' 55.35" East Longitude, with an area of 774.8 km<sup>2</sup>. As a result of the material extraction process, a mass of weak rock is exposed on the slope's surface, which is feared to cause landslides.

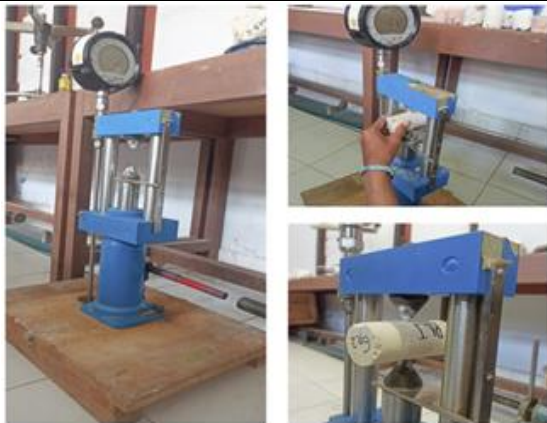
Figure 4. Compressive Strength Testing Using Point Load Machine (Geotechnical Laboratory, Universitas Cenderawasih)

After the rock has been cored and tested with Point Load Index, PLI (diametrical testing), the test result data is obtained in table 3 below.

Based on the data processing that has been carried out, it can be concluded that the compressive strength value,  $\sigma_c$  of the rocks forming slope 1 is 21.6 MPa, slope 2 is 22.7 MPa, and slope 3 is 25.3 MPa.

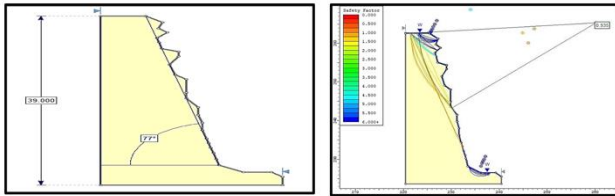
Figure 6. Slope geometry 1 (left), Slope FoS value in original condition (right)

From the analysis of the level of slope stability, which was carried out using slide 6.0 software, the slope safety factor value for the research area in original conditions was 0.935, dry conditions were 1.619, and saturated conditions were 0.671. So it can be concluded that the slopes of the research area, when original and saturated, are unsafe or unstable. In contrast, the slopes in dry conditions are safe or stable. The FoS value indicates that the slope conditions at the research location have the potential for landslides in original and dry conditions.

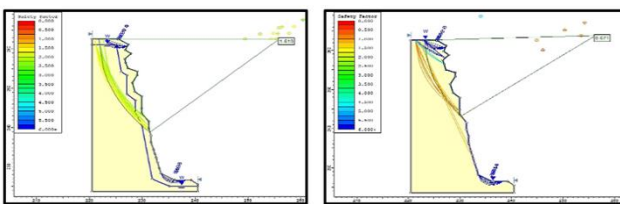
Figure 7. Slope FoS value in dry conditions (left), Slope FoS value in saturated conditions (right)

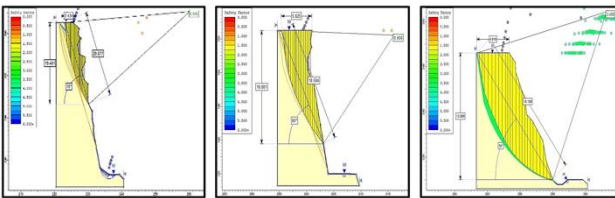
Figure 8. Analysis of Slope 1 (left), Slope 2 (middle), slope 3 (right)

Based on the analysis of the FoS value of the research slope using the Hoek & Brown method, which was carried out on slope 1, the FoS value of the research slope in actual conditions in the field was 0.387, so it can be concluded

that the research slope is in an unstable/unsafe condition. Analysis of Slope Safety Factors Using the Hoek & Brown Method Manual analysis using the Hoek & Bray method was carried out to determine the value of the safety factor for the research slope under actual conditions in the field, the results of which can be visually observed in the following image.

Based on the analysis of the FoS value of the research slope using the Hoek & Brown method, which was carried out on Slope 2, the FoS value of the research slope in actual conditions in the field was 0.579, so it can be concluded that the research slope is in an unstable/unsafe condition. Based on the analysis of the FoS value of the research slope using the Hoek & Brown method, which was carried out on Slope 3, the FoS value of the research slope in actual conditions in the field was 1.272, so it can be concluded that the research slope is in a safe condition.

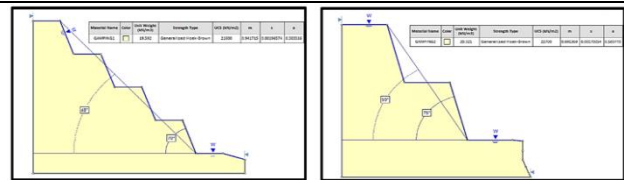
Figure 9. Overall Slope and Single Slope Slope 1 (left) and Overall Slope and Single Slope 2 (right)

Table 6. Recommended Values for Slope Design

No.	Quarry	Level Height (m)	The width of the road (m)	Over All Slopes (degree)	Single Slope (degree)	FoS
1.	Slope 1					
	Original	9	6	48	70	2,257
	Saturated	9	6	48	70	2,179
2.	Slope 2					
	Original	9	6	54	75	2,884
	Saturated	9	6	54	75	2,703
